Manhole Inspection Summary

Manhole # S23MM_041MH

Insp Date: **7/4/05 9:36 PM**

Location Address: **2487 DRUID HILL AVE**

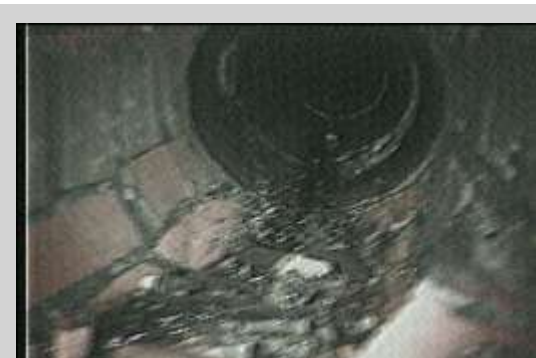
8 in. Circular Gravity Sewer Pipe In @ 3 O'Clock

Deposits: ☒ **None** ☐ Mud ☐ Sludge ☐ Debris ☐ Grease

Infiltration: **None** Pipe Seal Cond: **Unknown**

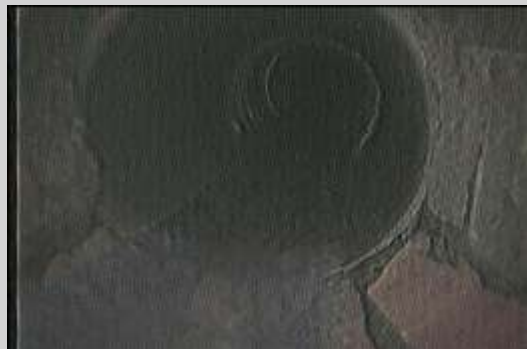
8 in. Circular Gravity Sewer

Infiltration: **None**
